Xbloc
Gouda

Date 28 February 2024
Our reference DMC-240228-B-00001-PB
Handled by
Telephone
E-mail
Page 1 of 6
Subject **Risks of Accroberm toe protection**
Projectnumber **968000**

From time to time DMC receives questions about the application the Accroberm™ concrete unit without a rock toe in front of it and why DMC doesn't apply such a solution with Xbloc. The Accroberm™ solution is presented by CLI as a substitute for a rock toe and as a substantial cost saving.

DAMAGE PROGRESSION OF A RUBBLE MOUND BREAKWATER WITH ACCROPODES II AND ACCROBERM I ARMOUR UNITS USING IMAGE-BASED APPROACHES

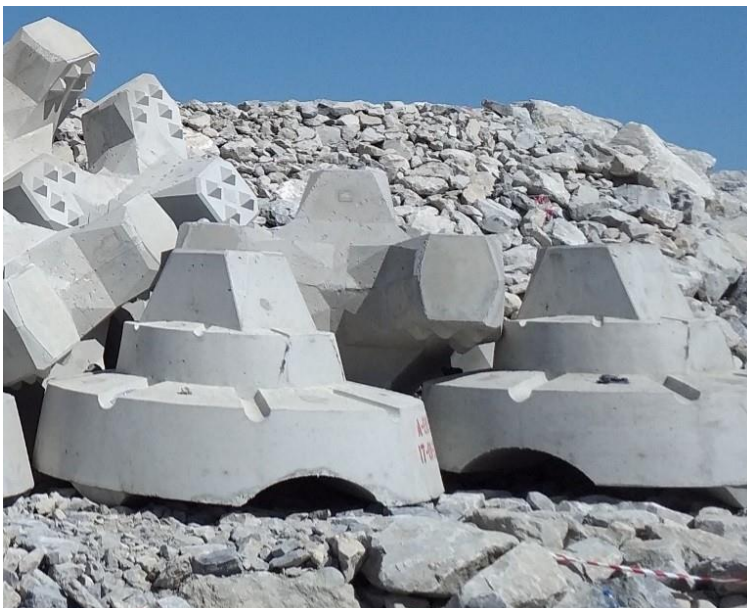
Figure 2: example Accroberm™ on very fine stones (from CLI website)

For good accurate placement and a good connection between the first 2 rows, it helps if the rocks underneath the Accroberm™ unit are small, as shown in Figure 2. However, in this situation the fine rocks will be washed away by the waves and eventually the Accroberm™ units will be undermined. (See also section below about the trial project with Accroberm™.)

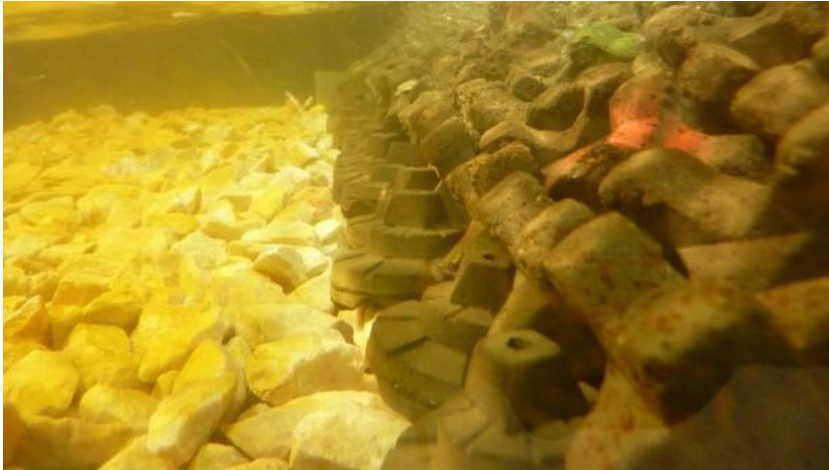
Figure 3: Accroberm™ placed on large rocks during model tests (CLI website)

If the Accroberm™ is placed on larger rocks as shown in Figure 3, the rocks will be more stable against the waves. However from projects with Xbase we know that placement on top of larger rocks becomes more difficult. Therefore the connection between the Accroberm™ and the Accropodes™ row is expected to be more difficult when placed on large rocks. This in its turn leads to risk of instability.

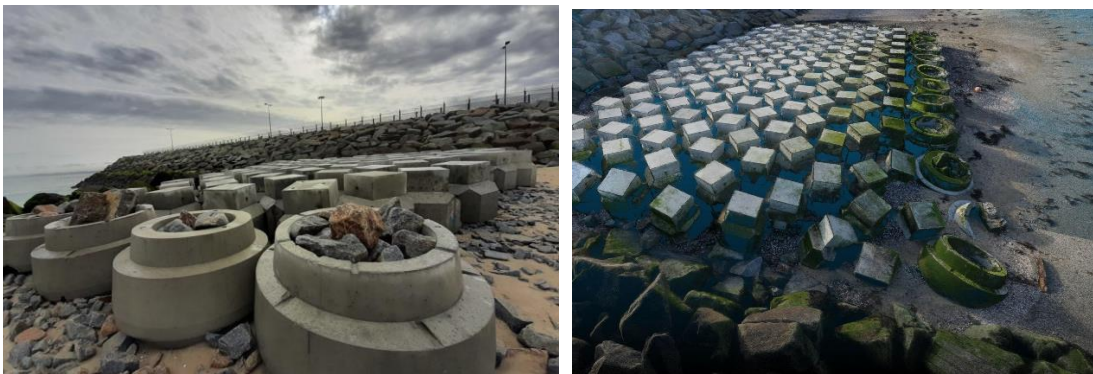
Some photos are shown below where it can be seen that the Accroberm™ blocks have shifted seawards. In this case the blocks seem to be placed on a gravel layer on a beach. It may be possible that the shifting of these blocks is due to undermining of the beach in front of the structure. However the trial does demonstrate the risk of instability if the bedding layer underneath the Accroberm™ is undermined.

Figure 4: Photos of Accroberm prototype project in France

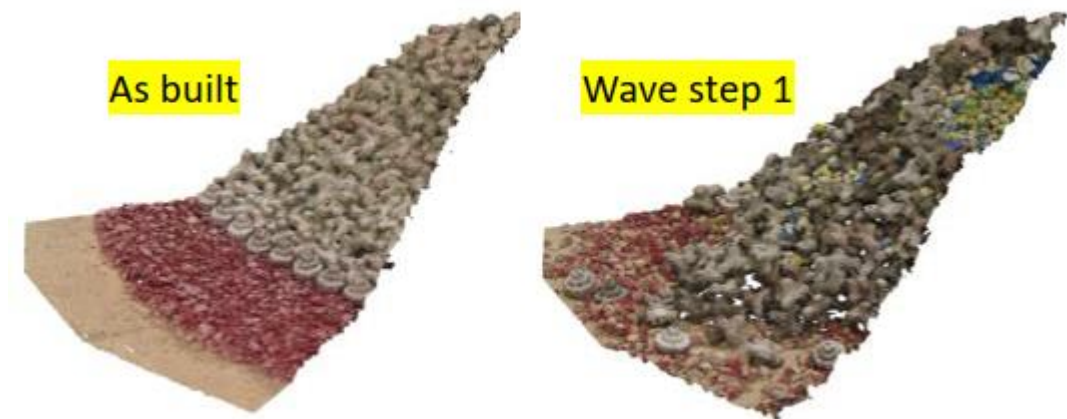
The tests consisted of repeated test with waves of 120% of the design wave height. Such overload conditions are commonly applied during physical model tests with single layer armour units to prove the resilience of the design against higher waves. Typically a duration is applied of 1000 waves or a prototype duration of 6 hours which would contain 1728 waves in these tests. During the first tests with only 500 waves however, several displacements of Accroberm™ units and failure of the breakwater roundhead was observed.

Figure 5: Photo of as-built section of roundhead and damage after test series 1

During the subsequent test series, failure of the trunk was also observed. The tests show that the Accroberm™ does not provide resilience against the tested overload conditions.

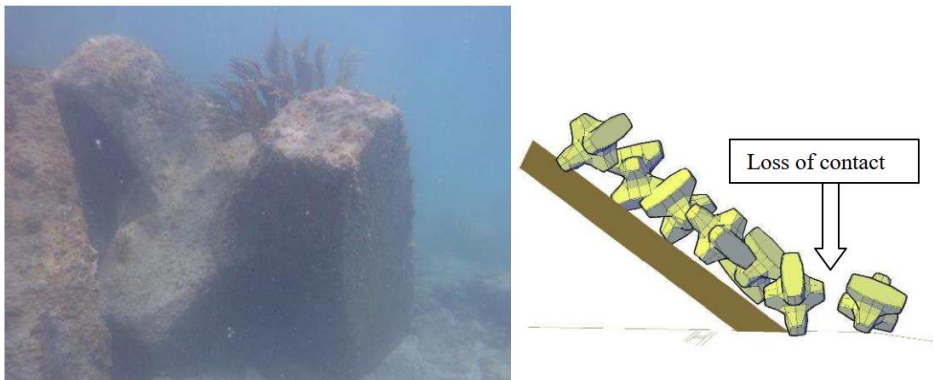
The inspections have confirmed that the unsupported units can tilt over and become disconnected from the armouring. On several structures, the first row of ACCROPODE™ units was found to be no longer in contact with the rest of the layer (Figure 11). Therefore, the armour layer remains unsupported by the toe units and is sometimes “hanging” above the first row without touching it. It was not possible to determine when the isolated first row of units was extracted (at the construction or afterward). Such disconnection can take place when placing the second row of units, under storm conditions, or later when the lower layers (bedding layer for example) settle. The inspections have revealed that, the contact between the rocks and the first row of units is important to secure the units and prevent them to move away or tilt over. Specific attention is to be paid when placing the rocks in contact with the concrete units.

Figure 11. Example of disconnected unit at the structure's toe (left) and illustration of the disconnection of the first row of units (right).

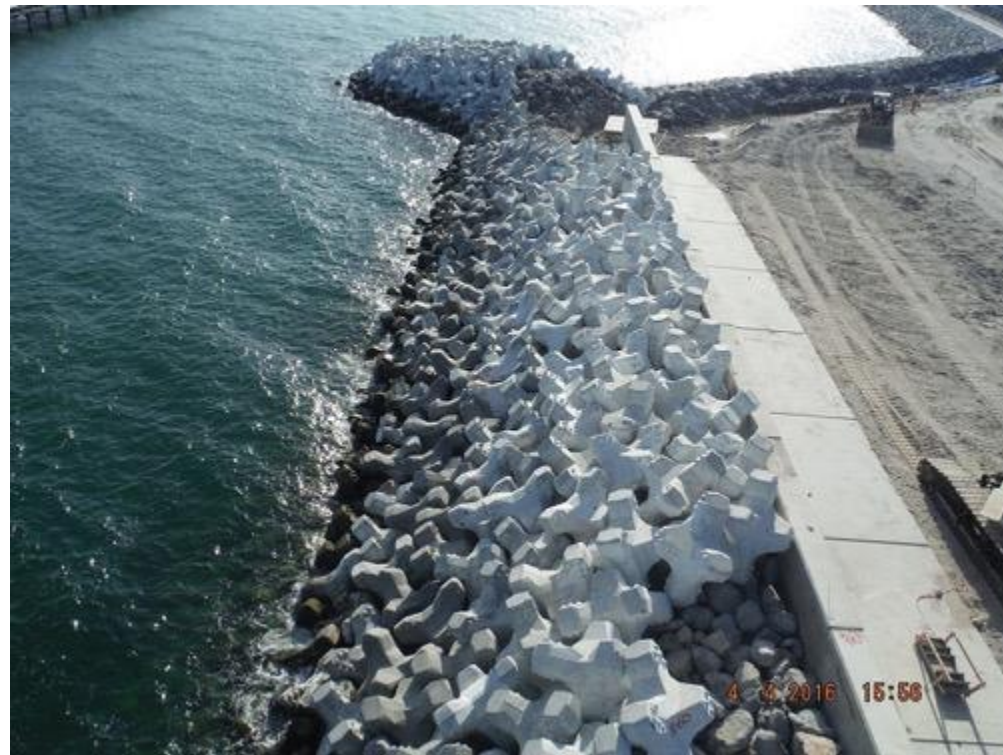
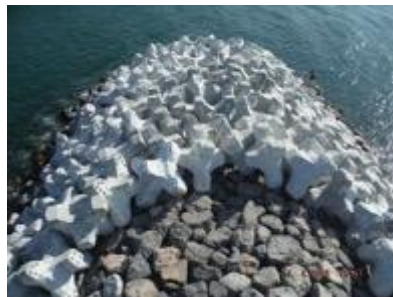
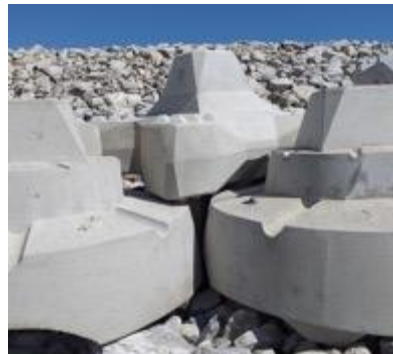
- **Rubble mound breakwaters** are built for coastal protection and wave energy dissipation.
- **Accropode II** units' unique design ensures robust interlocking, minimizing wave-induced shifting or dislodgment.

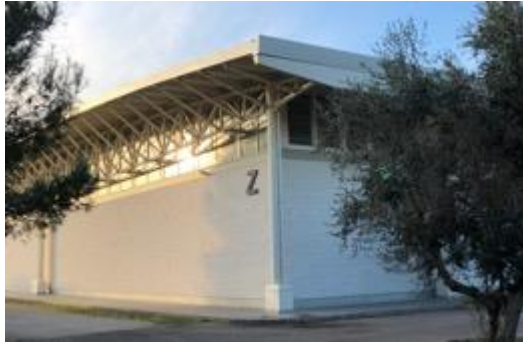
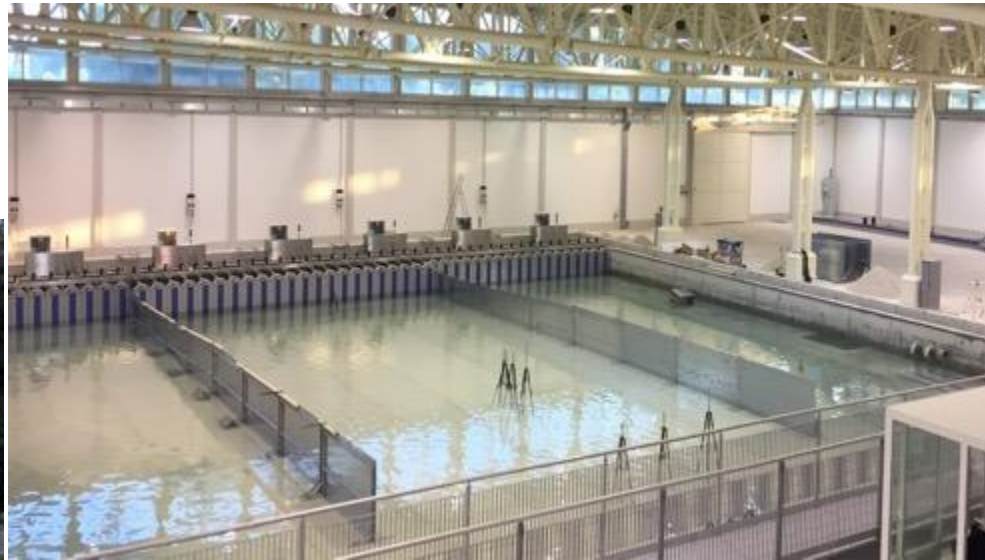
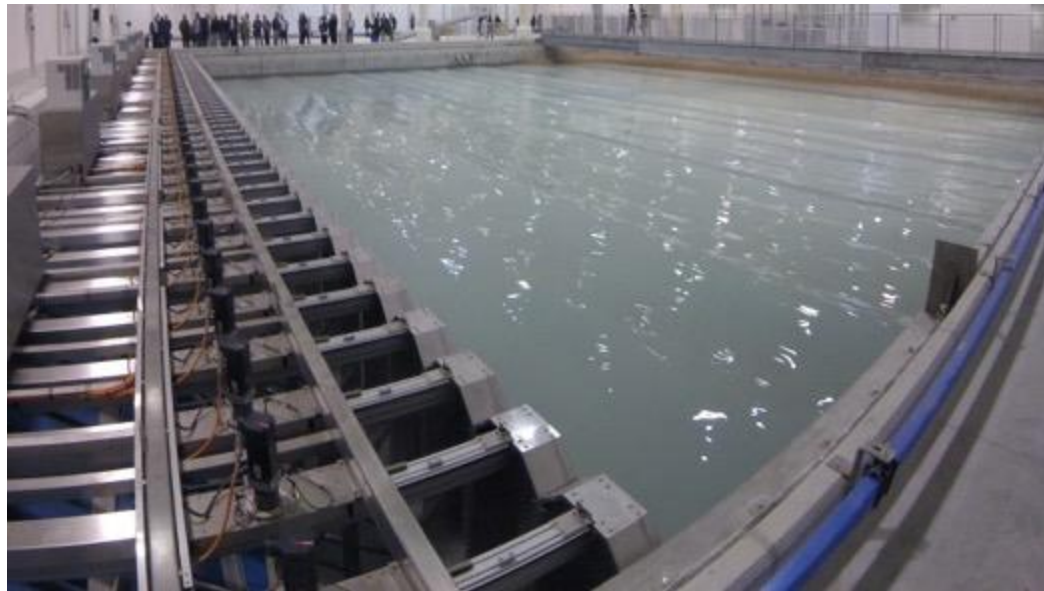
3D Wave Basin

- 29.5 m long, 28 m wide and 1.6 m deep;
- piston-type wave generator;
- spending beach at the end of the basin.

Unidirectional and directional wave fields,
regular waves and wave spectra.

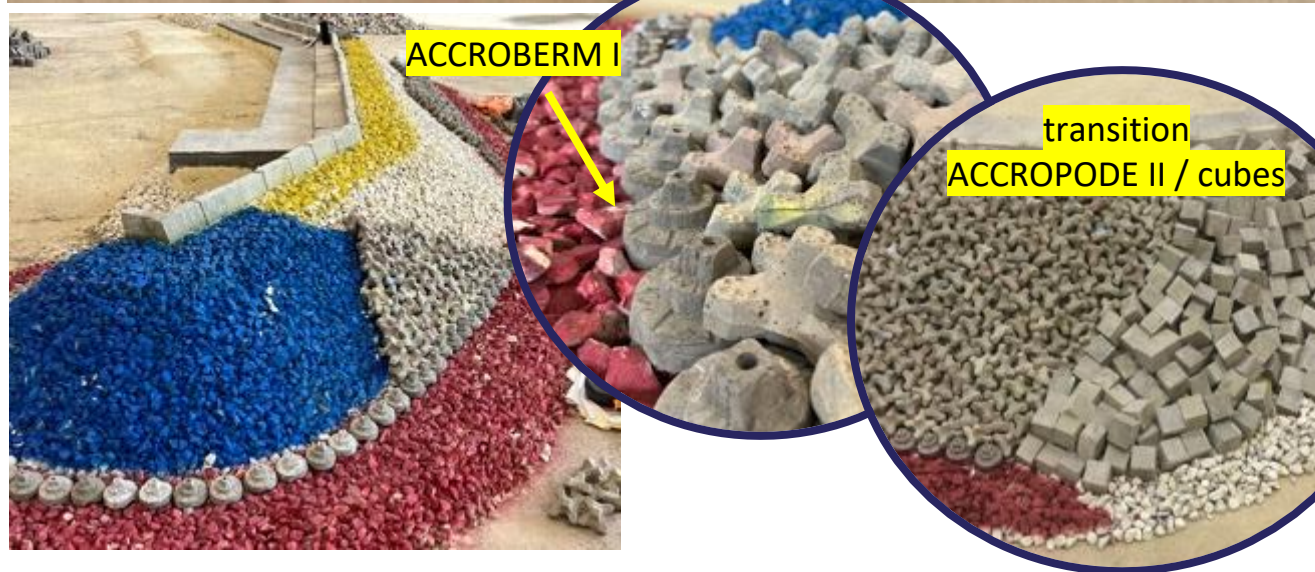
Experimental set-up

Potential extreme scenario

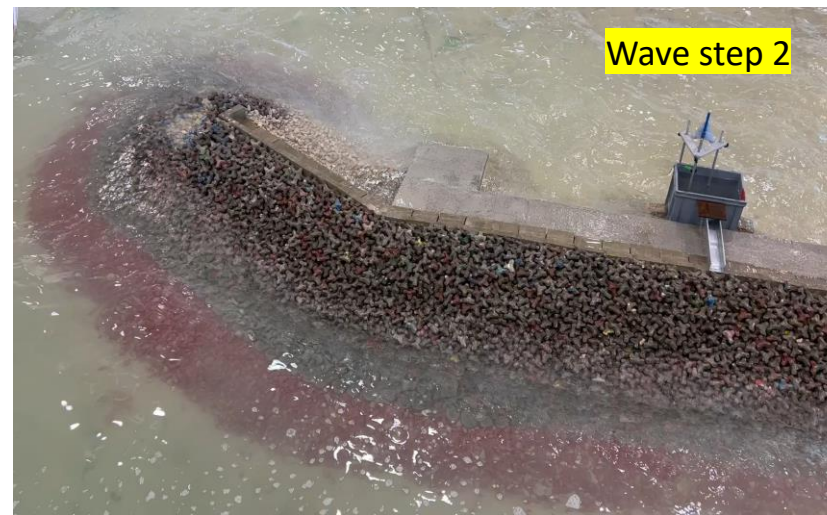
Survey with Unmanned Aerial Vehicle (UAV) equipped with a high-resolution camera after each wave step

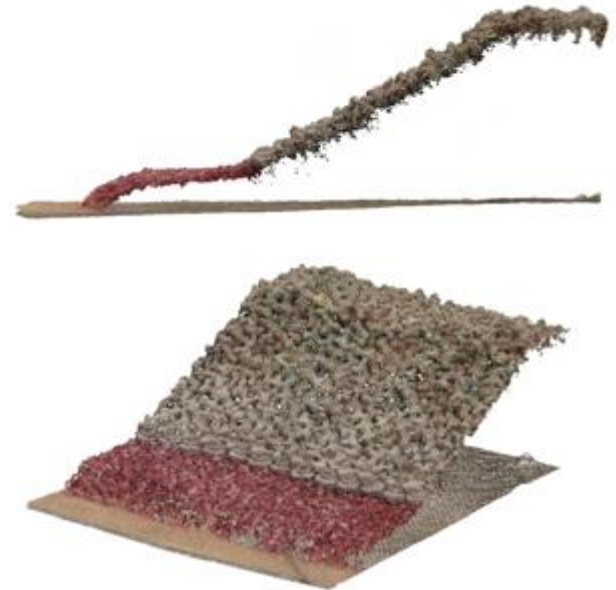
Sector definition

- model footprint division into 10 sectors (circular sectors at roundhead).

- pre-construction and post-construction point clouds gained by UAV-based bathymetry survey;
- statistical outlier remover;
- subtraction of point clouds for sector volumes.

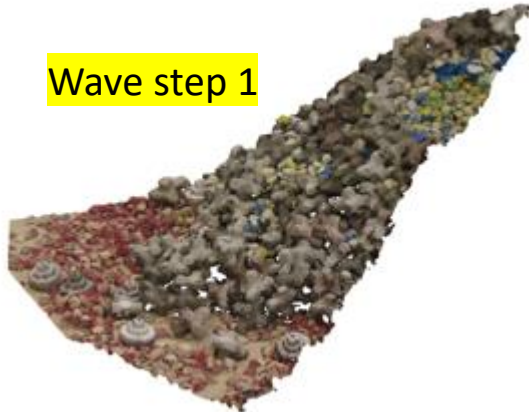
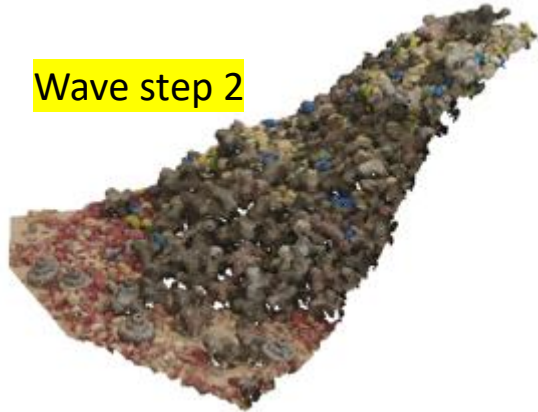
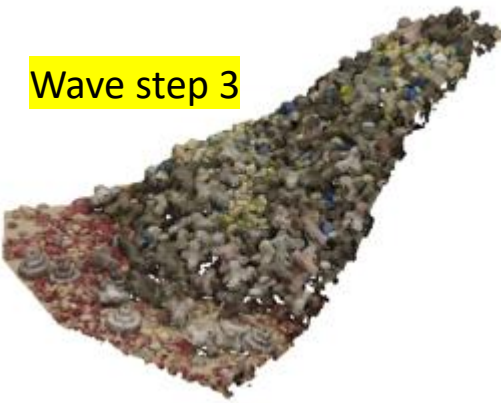
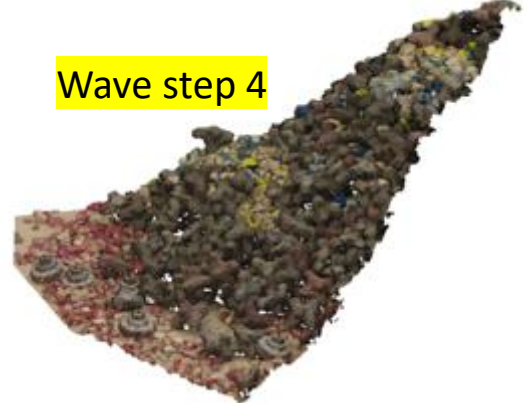
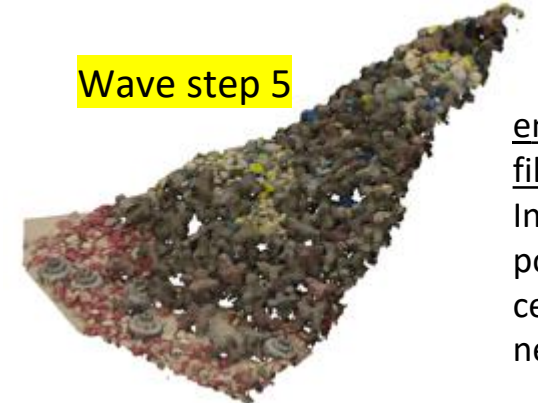
- volume calculated using parallelepiped volume summation, with base area as elementary cell area and height as z-coordinate difference ($dV = \text{grid step} * \text{grid step} * \text{distance}$);
- calibration, based on known-size armor units, determined optimal 1 mm grid step for volume computation, matching shifted armor units with observed count.

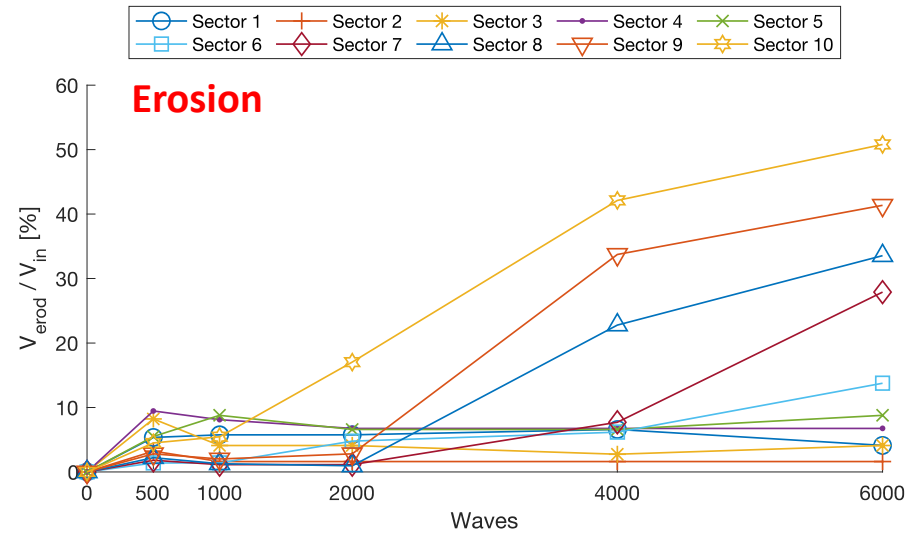
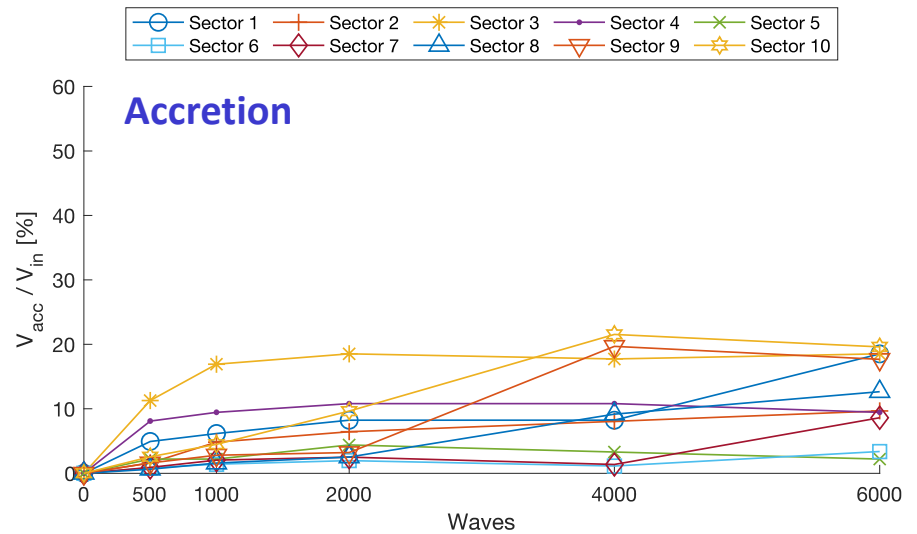
Erosion - accretion maps

As built Wave Step 1 Wave Step 2 Wave Step 3 Wave Step 4 Wave Step 5

- **Critical points identified:**
 1. **port side:** erosion up to 15% and accretion up to 20% at sector 1 (accretion from sectors 6 and 7);
 2. **roundhead:** distributed erosion within 1000 waves at sectors 4, 5 and 6 up to 10% for each sector and accretion up to 20% at sector 3;

3. **trunk:** critical transition zone (cubic rocks to innovative units):
 - within 2000 and 6000 waves: progressive erosion from sector 10 to 6;
 - at 6000 waves: maximum erosion of 50% and accretion of 20% at sector 10 (some armour units and part of the filter layer beyond assessment domain).
